# SIMONTON LAKE WATERSHED MANAGEMENT PLAN

October 06, 2018

## **EXECUTIVE SUMMARY**

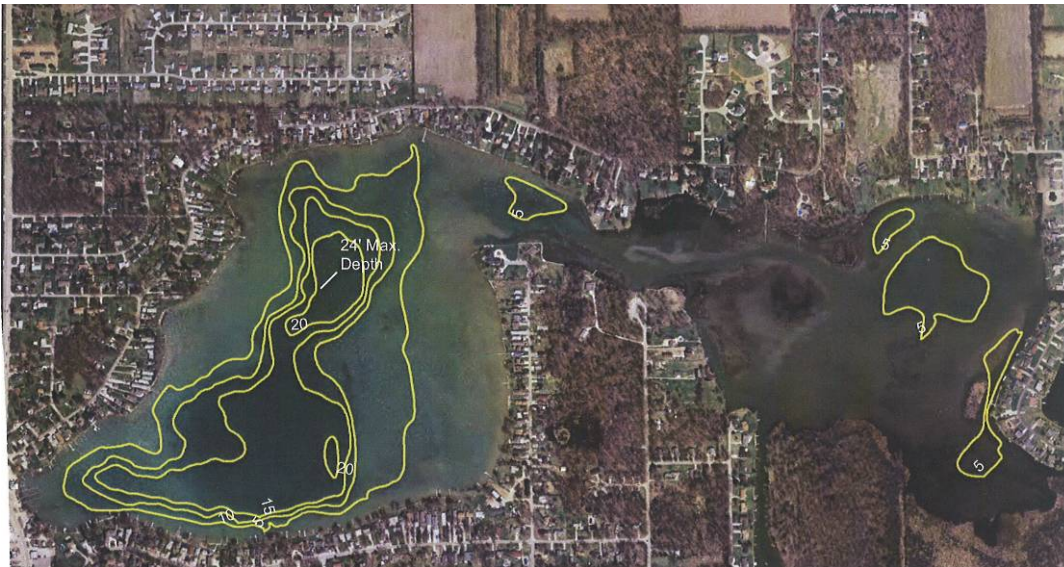
Figure 2. Simonton Lake Bathymetric Map. Source, IDNR, 1955.

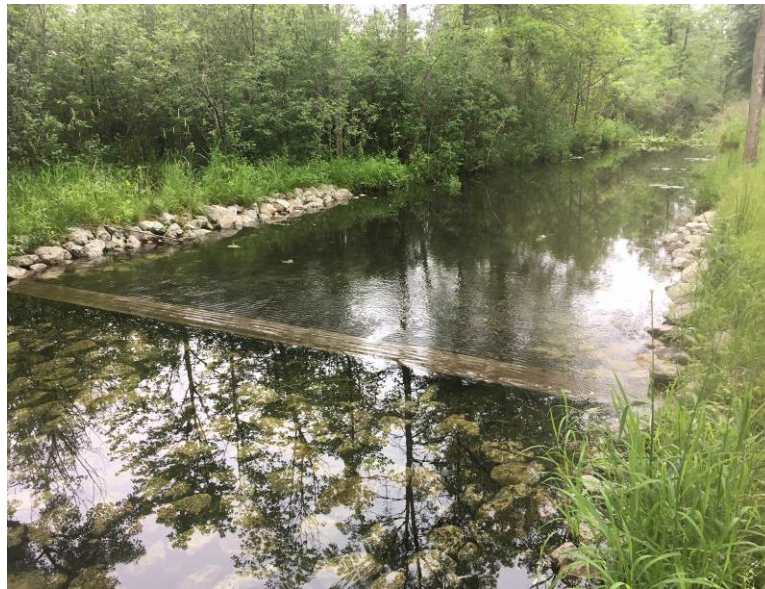
2.1 The outlet of Simonton Lake is the Osolo Township Drain (Lily Creek) with a recently installed weir elevation at 772.86. The water was 0.25 feet above the weir elevation at 773.11 on a June 12, 2018 inspection, with water at the same elevation on either side of the weir (Figure 10). The lack of better flow downstream of the weir is keeping Simonton Lake approximately three inches higher than its legal lake level. The higher lake level may contribute to flooding issues on the north side of the lake.

**Figure 10: Simonton Lake weir approximately 450 feet south of the Simonton Lake east basin on June 12, 2018.**

3.1 The Oslo Drain has long been off limits to cleaning and reconstruction within ½ mile of Simonton Lake due to the Indiana Public Law that does not allow the dredging of a ditch or stream within ½ mile of a lake in order to protect the lake level. To prevent the lowering of the lake and allow cleaning further downstream a rock grade control structure was installed in Oslo Ditch just north of the Toll Road about ¾ mile south of the lake. The structure was designed to protect the bottom of the channel from erosion by armoring the substrate with rock. The structure does not impede the flow of water.

The structure allowed the upstream ditch bottom elevation to remain the same while cleaning took place downstream. With the weir now installed to protect the lake level, the County Surveyor could apply for a DNR permit to clean Lily Creek from the Toll Road north to the weir, however, they would most likely have to avoid cleaning the ditch where there is adjacent wetlands. There are wetlands adjacent to the ditch for several hundred yards downstream of the weir. Cleaning the ditch to the weir would help reduce the height of water flowing over the weir.

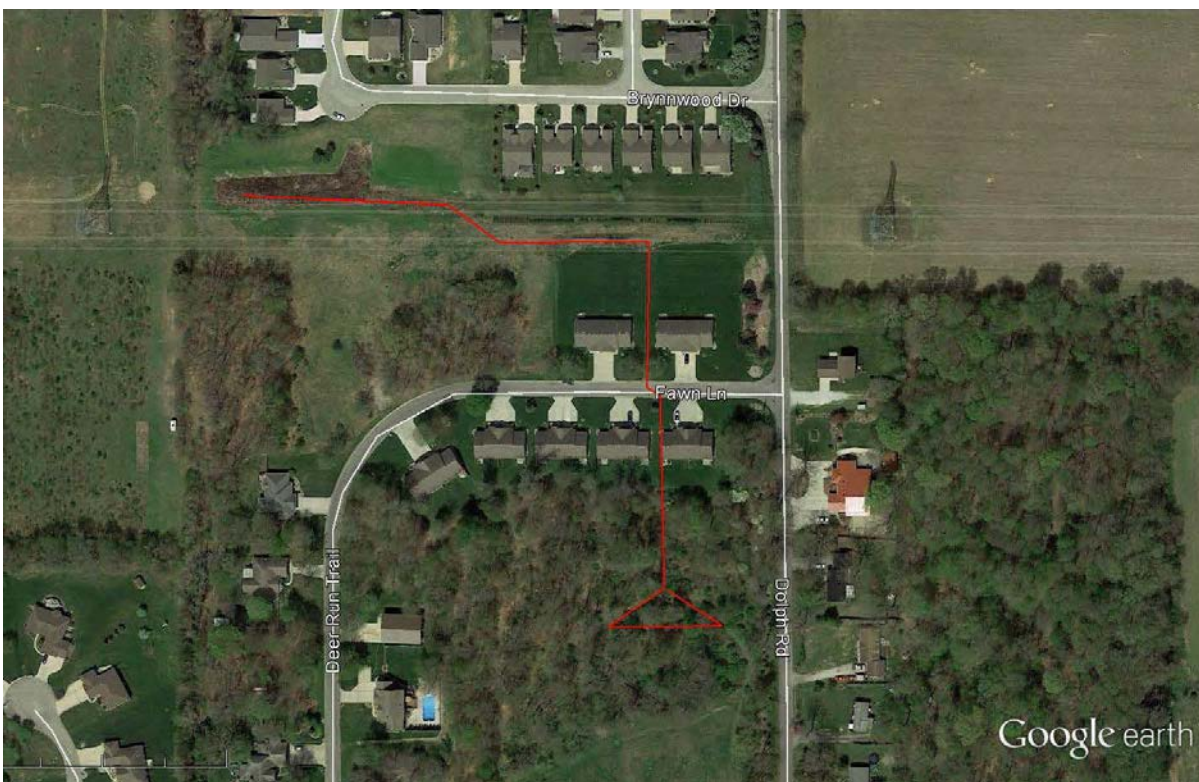
- 2.2 The channels area at the east end of the lake has limited and temporary standing water on the roads after heavy rains but is not causing any significant issues beyond temporary road hazards.
- 2.3 The drainage at the northeast corner of the lake from Northshore Drive in the vicinity of Beech Drive was noted as sometimes being an issue with the channel needing dredging due to in filling (Figure 11).
- 2.4 On Fawn Lane 170 -190 feet west of Dolph Drive is a drainage swale coming from the Brynnwood Drive subdivision to the north that empties onto Fawn Lane and then exits Fawn Lane at an offset curb cut on the south side heading toward a large undeveloped parcel of land which the drains to the lake (Figure 12). There was ample evidence of flooding with water and sediment on the road during the June 12, 2018 inspection (Figure 13-16).

**Figure 12. Drainage Path from Brynwood Subdivision retention, south across Fawn Lane toward lake.**

3.4 The flooding on Fawn Drive could be resolved by two projects. The first project would include cleaning, and if possible enlarging the detention basins within the Brynnwood Drive Subdivision. The second project would be to increase the size of the existing swales carrying water south to the lake or replace the swales with a drain pipe from the north lot lines of Fawn Lane Subdivision for the entire distance south to the lake. This drainage path should be designed to flow south along Dolph Road or follow the east lot lines of residential lots along east side of Deer Run Trail.

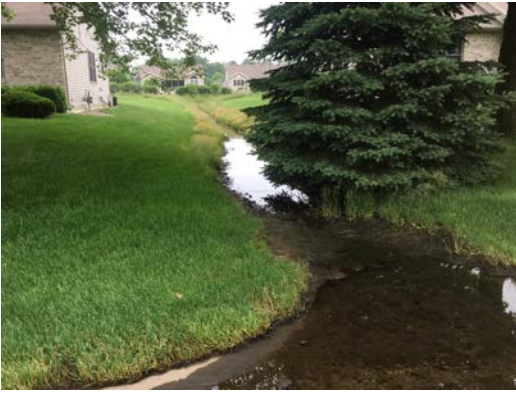
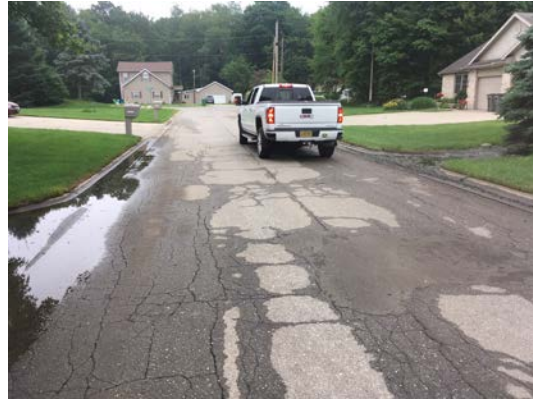
**Figures 13 and 14. Facing north from Fawn Lane and east on Fawn Lane at the drainage path from Brynwood Subdivision as it flows across the road heading south toward the lake.**

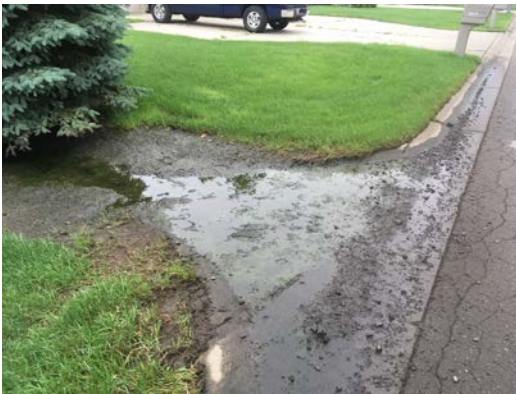
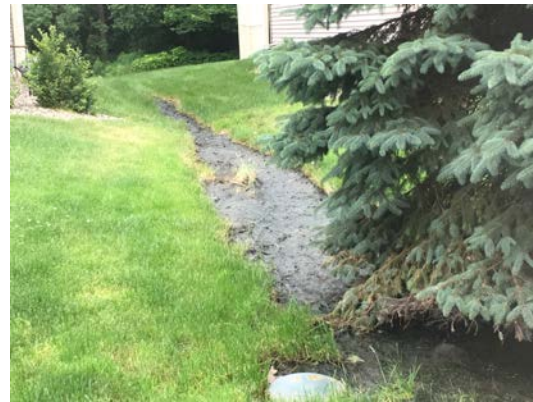
**Figure 15 and 16. Drainage Path from Brynwood Subdivision off of Fawn Lane toward lake.**

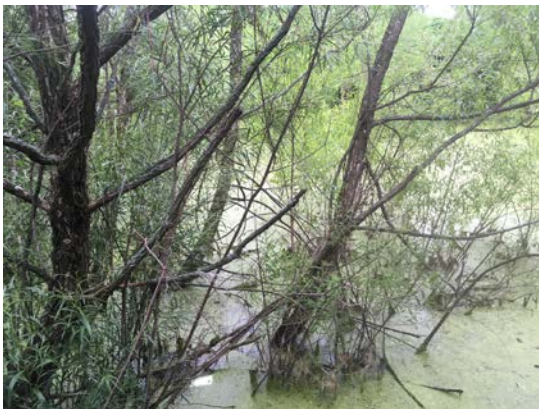
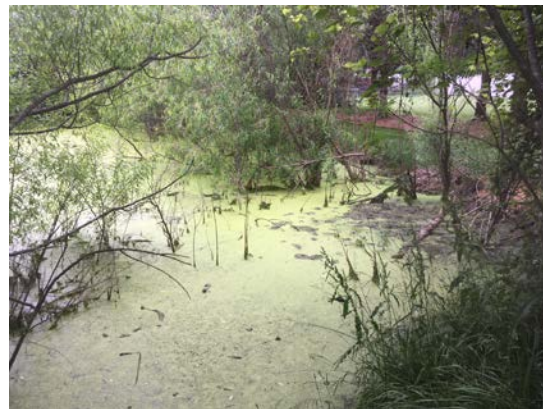
**Figures 18 and 19: Dutton Drive and Doe Meadows Detention Basin June 12, 2018**

3.5 The flooding within Doe Meadows Subdivision along Doe Meadows Place could be solved by constructing swales along the road or installing new drain pipe with positive flow from all of the lots in the neighborhood to an enlarged retention basin on the vacant lot. The existing, and any proposed new basin, needs an overflow pipe or swale that has positive drainage to the lake. Flooding of the streets and basements along Dutton Drive could be resolved in much the same manner. Drainage swales or culverts need to be reestablished along Dutton Drive where several occupied residential lots have filled the swale. These flow into the detention basin shared with Doe Meadows. This basin is currently acting as a retention basin and is at capacity with no free board. At a minimum an outlet for this basin needs to be established and the basin cleaned of vegetative growth.

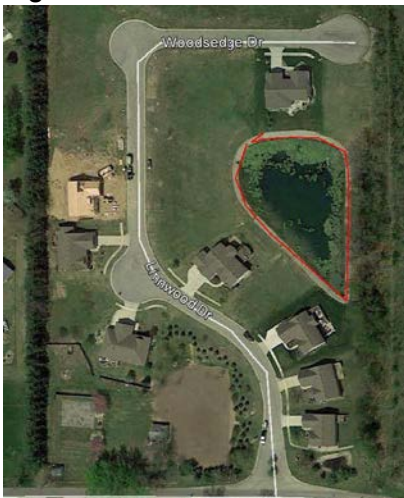
**Figure 20. Linnwood Subdivision Detention Area.**

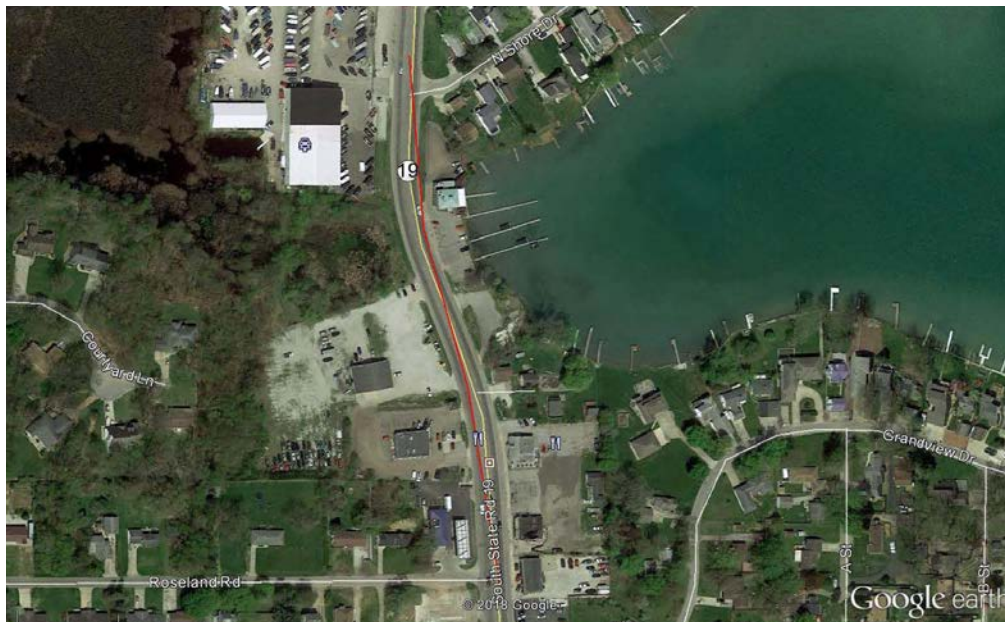
2.8 The drainage of State Road 19 at the west end of the lake was reviewed (Figure 24). The restaurant (Flippin Cow) experiences storm water flooding in their parking lot after every significant rain (Figures 25-26). The road is designed to send a majority of storm water from this section of road to the constructed basin on the west side of SR 19 using inlets on the lake (east) side of the SR 19. The constructed basin is not connected to the lake. However, it was noted that in several places such as the intersection of Northshore Drive and at the driveway entrance of the restaurant from SR 19, stormwater is overwhelming the inlets and running onto the restaurant property where it erodes and pools in their parking area. This is evident by several inches of sediment in their parking area adjacent to the lakeshore. Overflow from the parking area goes directly to the lake.

Figure 24: Drainage reach from north to south (1000 feet) onto Flippin Cow.

3.7 Perhaps one of the most noticeable issues is the flooding and sediment off SR 19 at the west end of the lake. Storm water consistently bypasses the existing drainage inlets along the east side of the Highway which carry stormwater to the basin on the west side of SR19. One solution is to install a “rolled curb” along this section of the highway that is 4 inches in height as opposed to the existing raised driveway slabs that provide only 1.5-2 inches of protection before the water flows onto the Flippin Cow parking lot. This extra 2 inches or more would force more water and sediment into the existing storm drain and sediment basin on the west side of the road. Along with that the adjacent owners should make sure these inlet structures are kept free and clear of debris. The other option is to put a continuous full height (6 inch) curb along the east edge of SR 19 and have the entrance to the Flippin Cow moved to North Shore Drive or the furthest south parking area. Cardno’s opinion is that this issue will require a design project sponsored either by the Conservancy District or the County Highway Department. A new curb of any type will require an Indiana Department of Transportation (INDOT) permit. In addition to a new curb design, the basin on the west side of the road that is not connected to the lake needs to be cleaned of all the sediment it has collected over the years. The sediment may be impeding the drainage from SR 19.

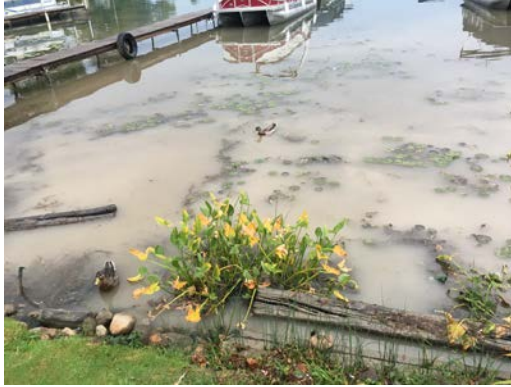
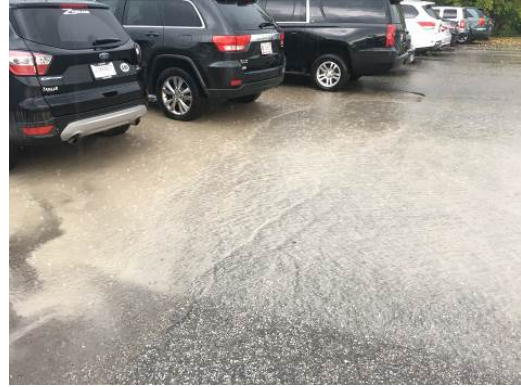
A direct quote from the landowner follows: "I've been there for 16 years and every time it rains my basement floods, my parking lot floods, dirt and debris from the gravel parking lot across the street washes into our parking lot. What dirt and debris doesn't settle in our parking lot ends up draining into the lake. During many rains there are waterfalls created running through my landscaping which have washed out my landscaping. Since I've own the property I've watched the lake depth go from nearly 6 feet to 2-1/2 feet at the end of my piers. I once had a nice sandy bottom everywhere and now it's all silt and I'm unable to even enter into the water on foot at my property".

**Figures 25 and 26. Stormwater runoff from State Road 19 at the Flippin Cow Restaurant.**

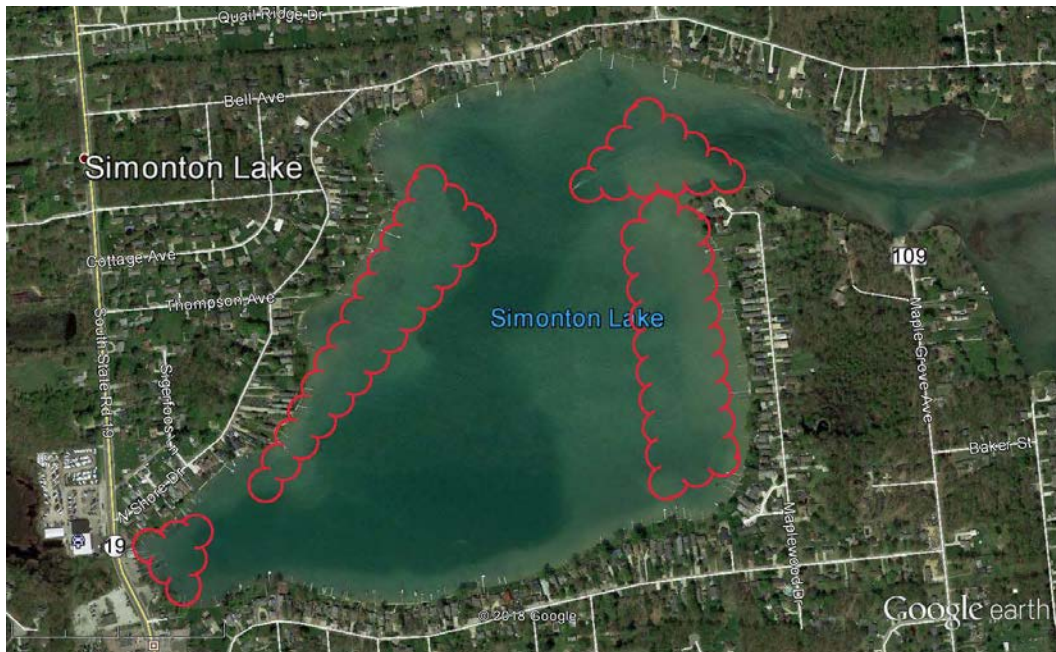
2.9 The sediment that has entered the west end of Simonton Lake from the runoff of SR 19 has affected the depth of the lake. The evidence for the depth of the sediment washed into the lake is mostly anecdotal such as the owner's statements in section 2.8 above. There is no historical depth data, other than the 1955 DNR bathymetric survey which only identified areas along the shore as being less than five feet deep. There is ample photographic evidence to support that sediment including salt, sand, and organic matter has washed off State Road 19 causing cloudy, silt laden water in the lake. There is ample research, described in section 2.10 that documents sediment resuspension and movement by motorized boat traffic in a lake environment. Whether this sediment is a few inches in depth or several feet or more can only be determined with sediment cores. The areas of concern brought up during this study include the majority of shallow water in the western half of Simonton Lake (Figure 27).

**Figure 27. Existing areas of sediment issues in Simonton Lake.**

3.8 The solution to the shallow areas in the west half of Simonton Lake is to dredge the shallow areas of accumulated sediment. The sediment can be mechanically or hydraulically removed. Mechanical removal would be accomplished by having two barges, one to carry the excavator and one to carry a container that could accept the sediment. The barge full of sediment could then be pushed to the shore and emptied into trucks for hauling the sediment to a disposal basin. Hydraulic removal, would involve a suction dredge and pumping the sediment to a contained disposal area off the lake. There is a significant cost for either method, but both have proven practical for this type of project.
