Simonton Lake Diagnostic/Feasibility Study Elkhart County, Indiana

May 2011

EXECUTIVE SUMMARY

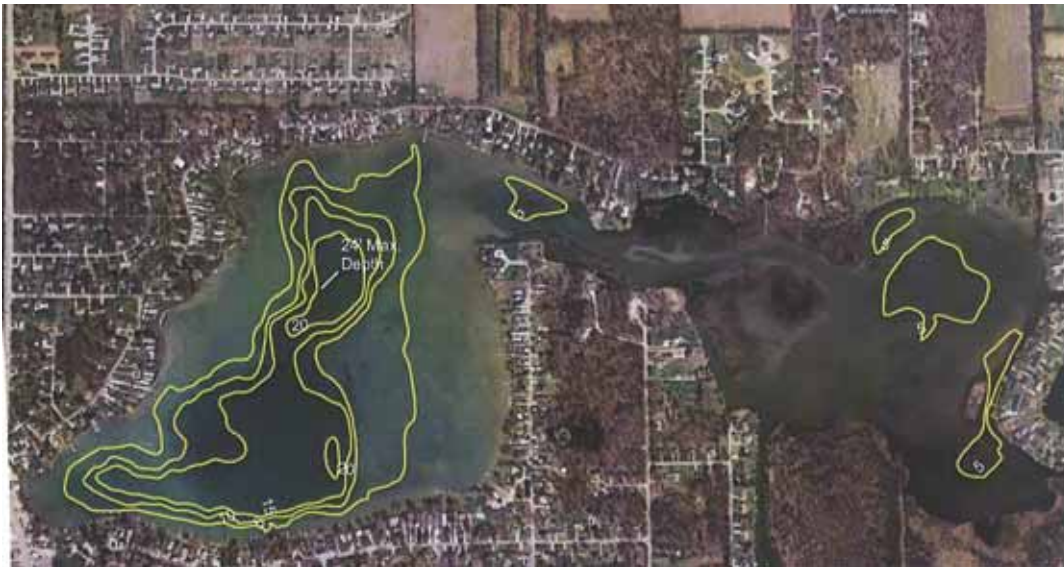
Figure 10. Simonton Lake Bathymetric Map. Source, IDNR, 1955.

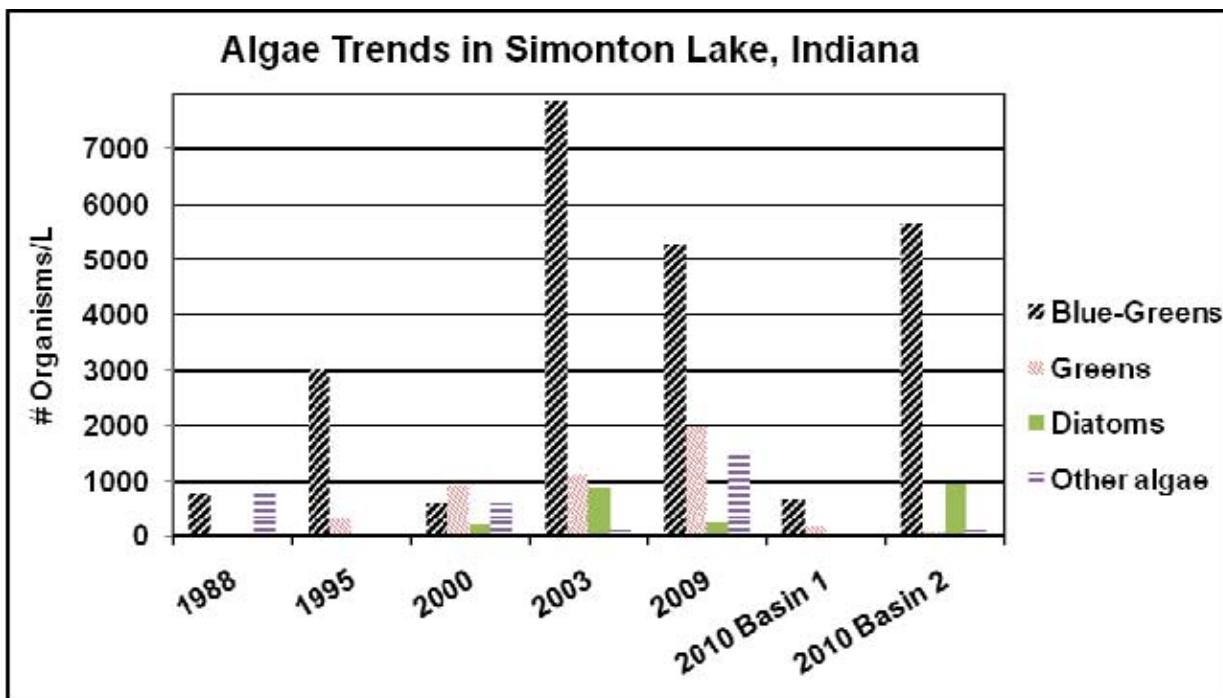
Since 2000, blue-green algae have become the dominant type of algae in Simonton Lake (Figure 17). In water samples collected July 6, 2010, we found very few green algae. Green algae are considered good for healthy lakes because they are readily eaten by zooplankton grazers. Zooplankton, in turn, are important food for young fish. Blue-green algae, on the other hand, are not as palatable and many zooplankton cannot eat them. Blue-greens often form nuisance blooms and many are known to produce toxins. Despite the dominance of blue-green algae, overall algal densities are relatively low in the lake. We can conclude that algae are not currently causing major problems in Simonton Lake.

Figure 17. Relationship between total phosphorus and algal abundance in Simonton Lake from 1988-2010. Source: Indiana Clean Lakes Program. West Basin (Basin 1); East Basin (Basin 2).

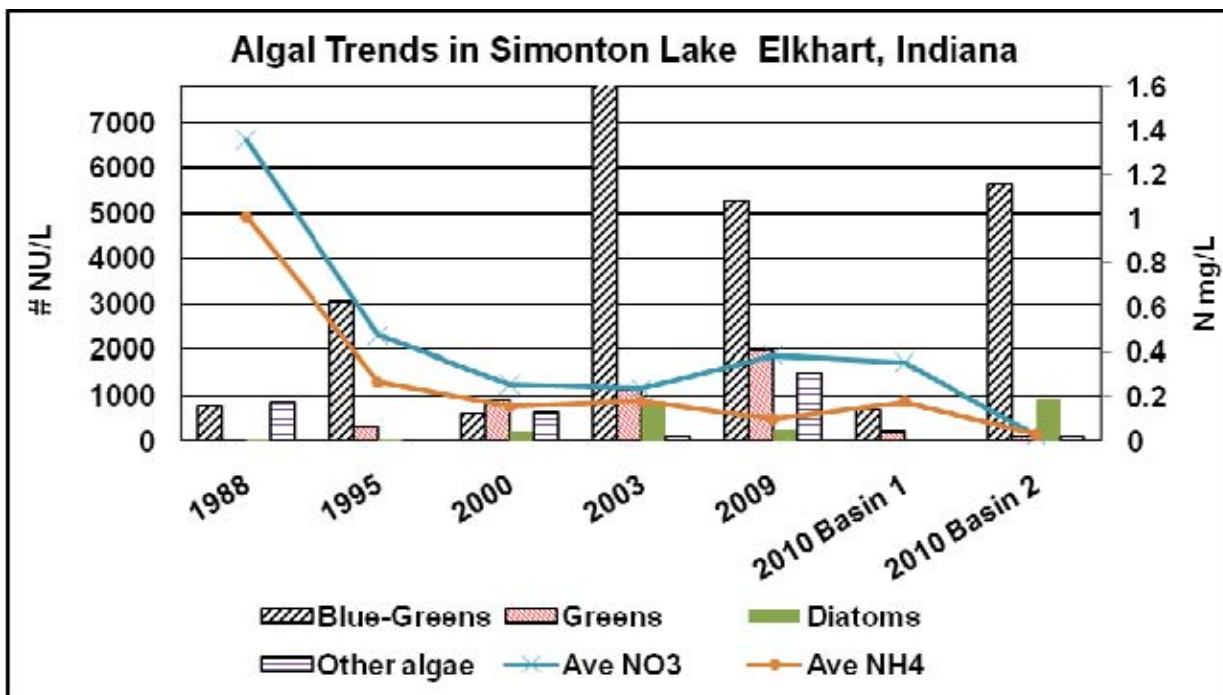
When we overlay the dissolved nitrogen (ammonia and nitrate) concentrations on the algae trends, we see an interesting relationship (Figure 18). Blue-green algae are known nitrogen fixers. They contain heterocysts, specialized structures where atmospheric nitrogen can be converted into ammonia for use in growth. Since the rise of blue-greens in Simonton Lake coincides with the fall in ammonia and nitrate concentrations, it would appear that with less available nitrogen, the blue-greens were able to dominate other algae because they can fix their own nitrogen. It is reported that low nitrogen to phosphorus ratios favor dominance by blue-greens (Smith 1983), but overall production of algae is controlled by phosphorus (Schindler et al. 2008). Thus, reducing nitrogen inputs to lakes may cause a shift in algal populations from greens to blue-greens, but reductions in phosphorus are required to cause a decline in overall algal production.

Figure 18. Relationship between dissolved nitrogen and algae in Simonton Lake from 1988-2010. Source: Indiana Clean Lakes Program. West Basin (Basin 1); East Basin (Basin 2).

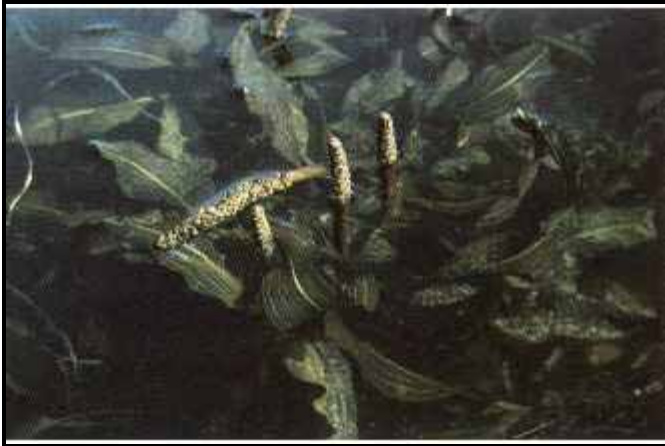
Figure 21. White-stem pondweed (*Potamogeton praelongus*) a state threatened submersed plant species found on Simonton Lake, August 27, 2010. Photo from <http://plants.usda.gov/java/profile?symbol=POPR5>

White-stem pondweed (*Potamogeton praelongus*) was found at two survey points during the summer survey (Figure 21). This plant has been listed as threatened in the state of Indiana (IDNR 2010). White-stem pondweed prefers clear and neutral to alkaline waters (Flora of North America). It is fairly easy to identify by its clasping leaf base and leaf tip. This is the only pondweed species that has these two characteristics. If found, please leave it undisturbed. No other rare aquatic plant species were collected during the survey.

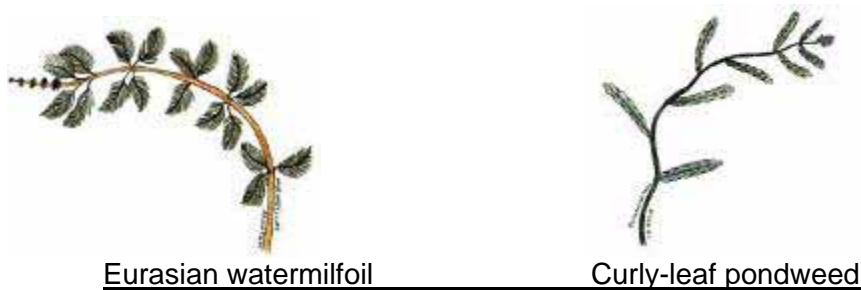
Figure 26. Invasive aquatic plant species found in Simonton Lake during 2010 Tier II aquatic macrophyte surveys.

Although they are not currently at the levels observed on many other regional lakes, Eurasian watermilfoil and curly-leaf pondweed are present in Simonton Lake (Figure 26). As invasive species, these species have the potential to continue to proliferate if left unmanaged, so data collected during the plant survey will be outdated quickly and should not be used to precisely locate individual plants or even stands. These two species are known to occur in the channels and are likely to spread to the lake if left uncontrolled. Treatment of these two species in particular should be considered a priority to prevent the continued spread into other parts of the lake.

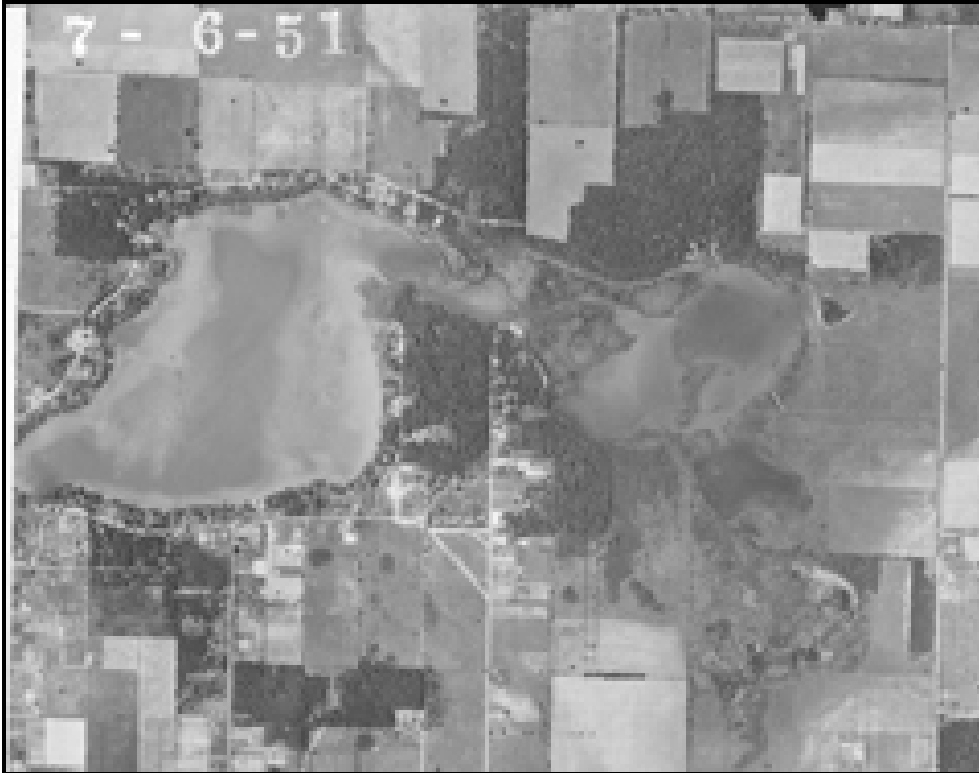
Figure 31. 1951 aerial photo of Simonton Lake.

As seen when comparing photographs from the 1950's to today, the emergent vegetation in the south eastern portion of Simonton Lake has been decreasing (Figures 31, 32, &, 33). Today, the shallow water in this area still contains many submersed and emergent species; however, constant wave action from watercraft has damaged this area. If protected, this area should recover. This will help not only the fish and wildlife, but also benefit the entire lake and its users. It will help provide better fishing, aesthetics, and increase water quality. JFNew recommends the Simonton Lake Area Home Owners Association create a petition to the IDNR to create an ecozone on Simonton Lake.

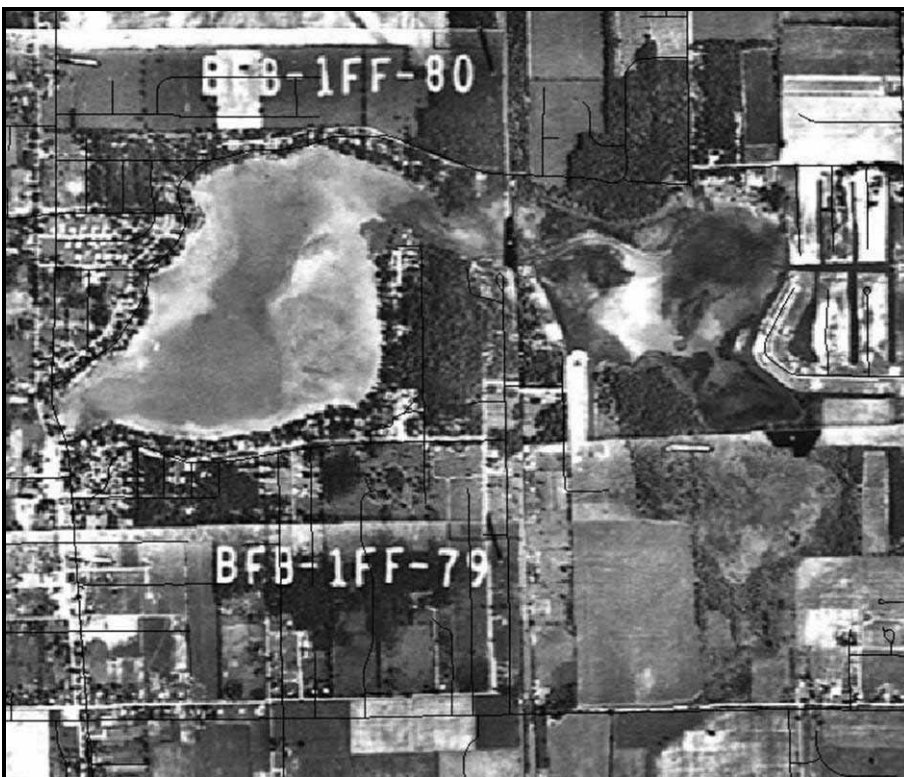
Figure 32. 1965 aerial photo of Simonton Lake.

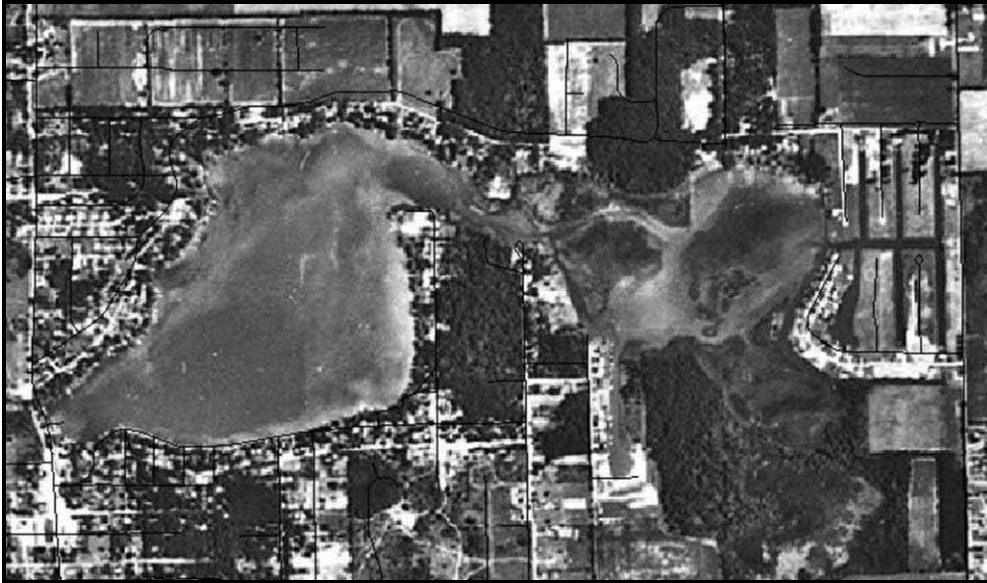
Figure 33. 1973 aerial photo of Simonton Lake.

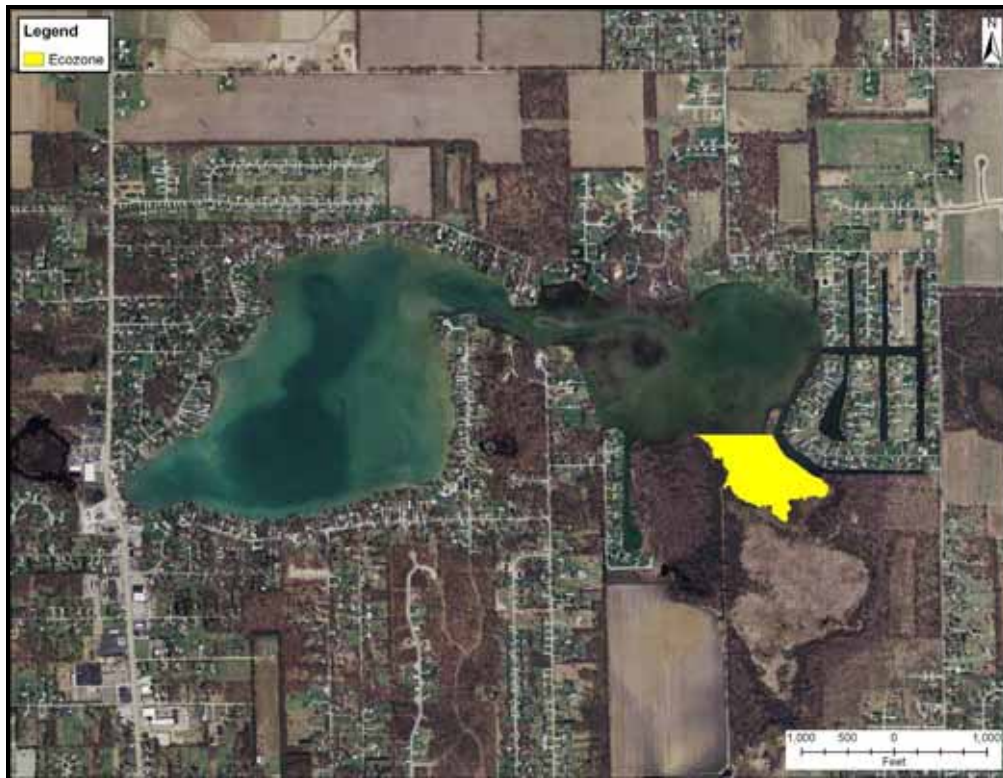
The proposed ecozone is in the southeast corner of Simonton Lake (Figure 34). The northern boundary of the ecozone would extend from the south point of the small island directly west approximately 850 feet (259 m) to the tip of the adjacent point. The eastern boundary is 125 feet (38 m) from the developed shoreline, giving property owners ample room to operate their watercraft. The southern and western boundaries are the respective shorelines.

Figure 34. Proposed ecozone location.

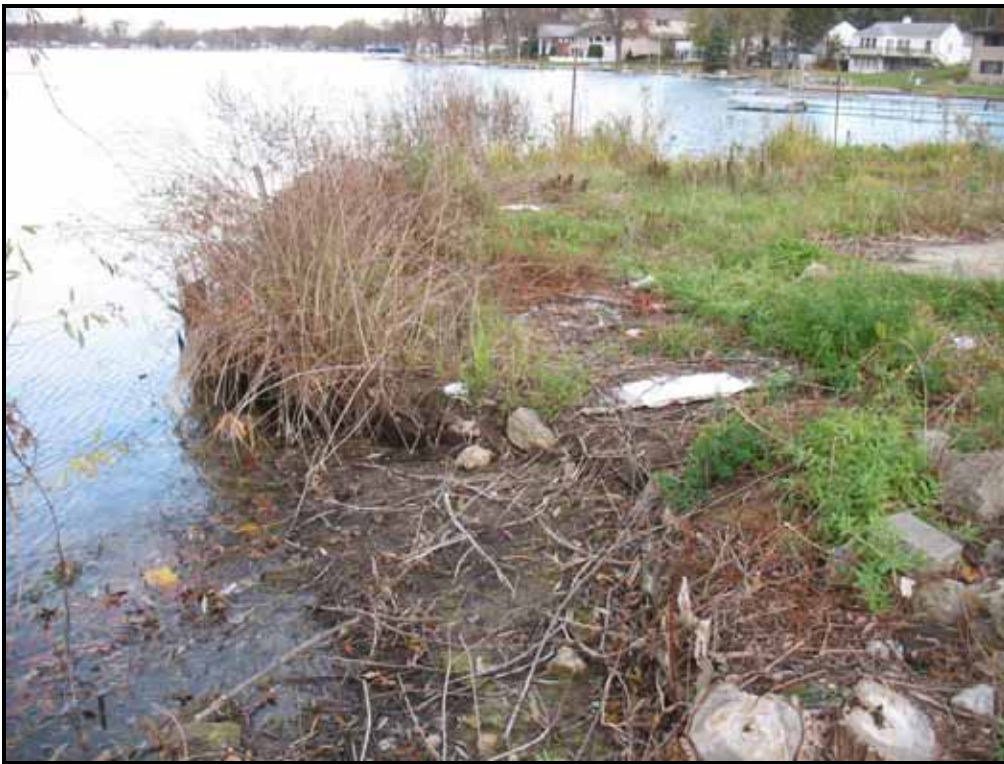
A parking area, a small outbuilding, and demolished building site make up the west end of Simonton Lake adjacent to State Road 19. These parcels sit at a low point on the landscape with adjacent properties and State Road 19 rising in elevation to the north and south. In the 1990's, State Road 19 was reconstructed to drain runoff from the road to a constructed basin west of SR 19, instead of into Simonton Lake. There is no surface water connection between the constructed basin on the west side of SR 19 and Simonton Lake on the east side of the road. The 50-75 foot wide lots on the east side of State Road 19 that slope directly into the lake, are mostly paved, and have a three to five foot buffer of grass between the paved area and the lakeshore. The lakeshore has minor erosion issues approximately six inches to a foot above the water line. This area is mostly vegetated, but is also armored with various rocks and debris (Figure 35).

Figure 35. Lakeshore along west end of Simonton Lake

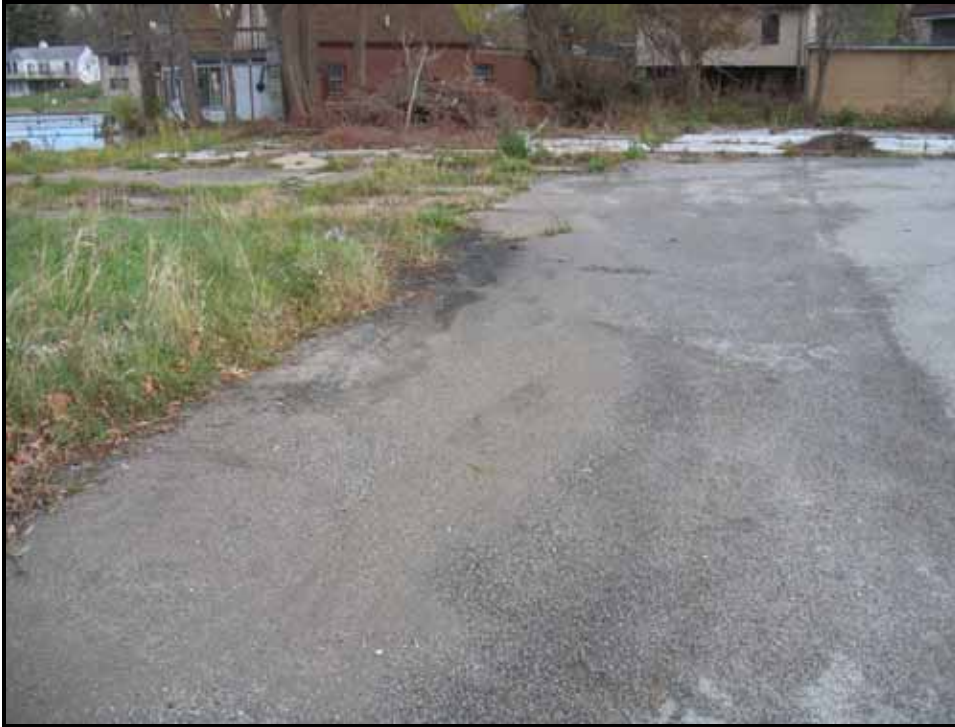
We identified an opportunity to improve the shoreline and filter or trap some of the sediment that washes to the lake from the paved areas as shown in Figure 36. We assumed that landowners would be interested in having the SLAHOA cost share with the LARE program to design and implement a project in this location. The proposed improvements that were never fully developed included adding glacial stone and native grasses and forbs to the shoreline to develop a fully vegetated shoreline approximately 2-3 feet high and constructing a berm and swale catchment on the uphill side of the shoreline treatment to intercept any sediments coming from the parking area. The captured sediments would have to be periodically removed from the site to maintain any structure

Figure 36: Parking area at west end of Simonton Lake

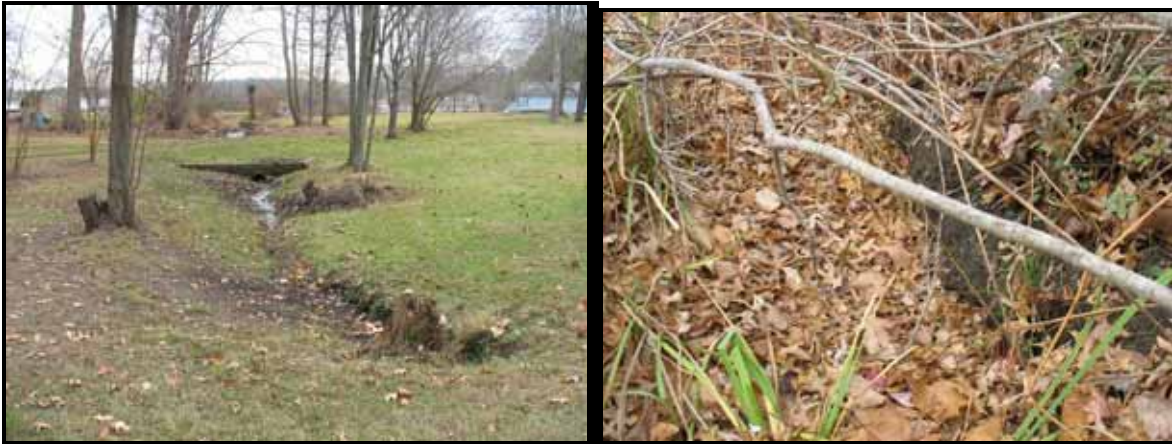
During the watershed tour and in a subsequent meeting with SLAHOA there were several suggestions made to the effect that a ditch across North Shore Drive had been blocked and was not allowing water to flow to the lake. Upon initial investigations with LARE staff we noted the existing inlet to the lake was barely visible in the woods to the north of North Shore Drive. The depth of the channel is approximately one foot with a top width of approximately two feet. The channel was dry and had very little evidence of flow. Upon inspection on the south side of North Shore Drive we noted a shallow drainage beginning approximately 50 feet from the road and heading to the lake (Figure 37). The drainage on average was approximately two feet below grade and had a top of bank width of 8-20 feet. There appeared to be some water in the lower part of the channel initiating from under an old stump part way down the channel. After meeting with the landowners of the two lots and obtaining permission to survey, we suspected there may be a connection, but it is not readily apparent. While the intent of the SLAHOA may have been for us to see about having the channel cleaned, it is JFNew's opinion that cleaning it would not help the lake in any manner, however; improving it to be a fully vegetated channel would help reduce the organic matter input to the lake and provide a pollution filter. With that in mind we sought and obtained permission to proceed with conceptual drawings for a potential project.

Figure 37: Facing Southeast(left) and northwest(right) at inlet drainage from North Shore Drive, Simonton Lake
